# Manhole Inspection Summary

Manhole # S05II2016MH

Insp Date: **7/7/06 1:31 PM**

**Location** Address: **2903 FALLSTAFF RD**

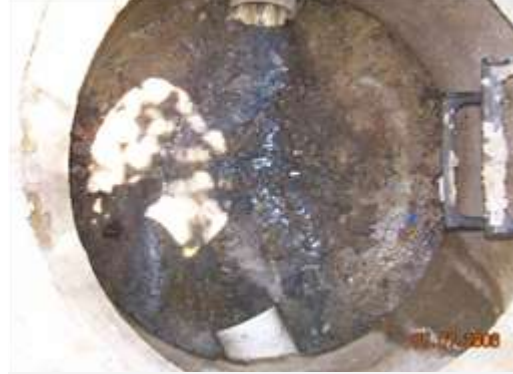
Top View

Corbel infiltration. Channel debris.

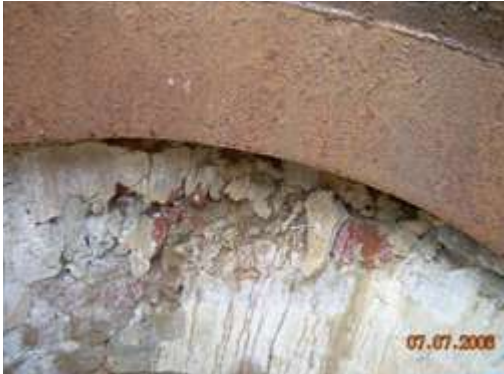
Defect

**Frame** Offset: **0** (in.) Condition: ☐ Sound ☐ Cracked ☒ **Leaks**

Condition: ☐ Sound ☐ Cracked ☐ Root Intrusion ☒ **Loose Brick** ☒ **Deteriorated**

Infiltration: ☐ None ☒ **Joint** ☐ Cracks ☒ **Mortar** ☐ Roots ☐ Wall

Frame leaks. Adjustment deterioration, loose brick and infiltration.

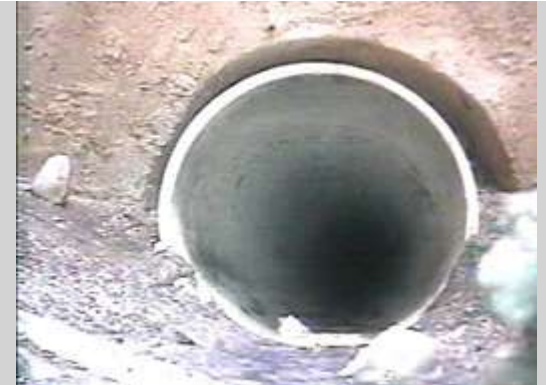
### 8 in. Circular Gravity Sewer Pipe Out @ 12 O'Clock

Comments **The O12 pipe seal is not flush to the pipe.**

Infiltration: **Evidence** Pipe Seal Cond: **Unknown**

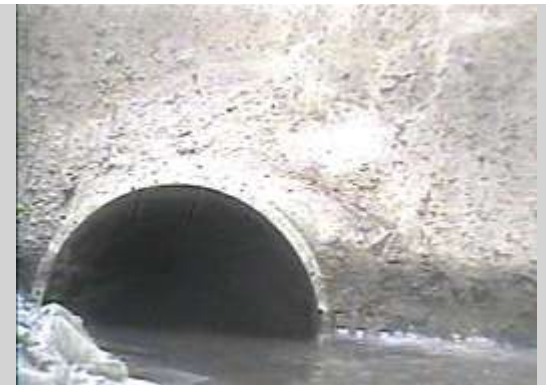
### 8 in. Circular Gravity Sewer Pipe In @ 6 O'Clock

Deposits: ☐ None ☐ Mud ☐ Sludge ☒ **Debris** ☐ Grease

Silt Depth: **2** (in.) Deposits Extent: **Light**
